# VTA Blossom Hill TOD Access Study

Phase 2 Technical Memorandum

Prepared for Santa Clara Valley Transportation Authority (VTA)  
by IBI Group  
August 4, 2020

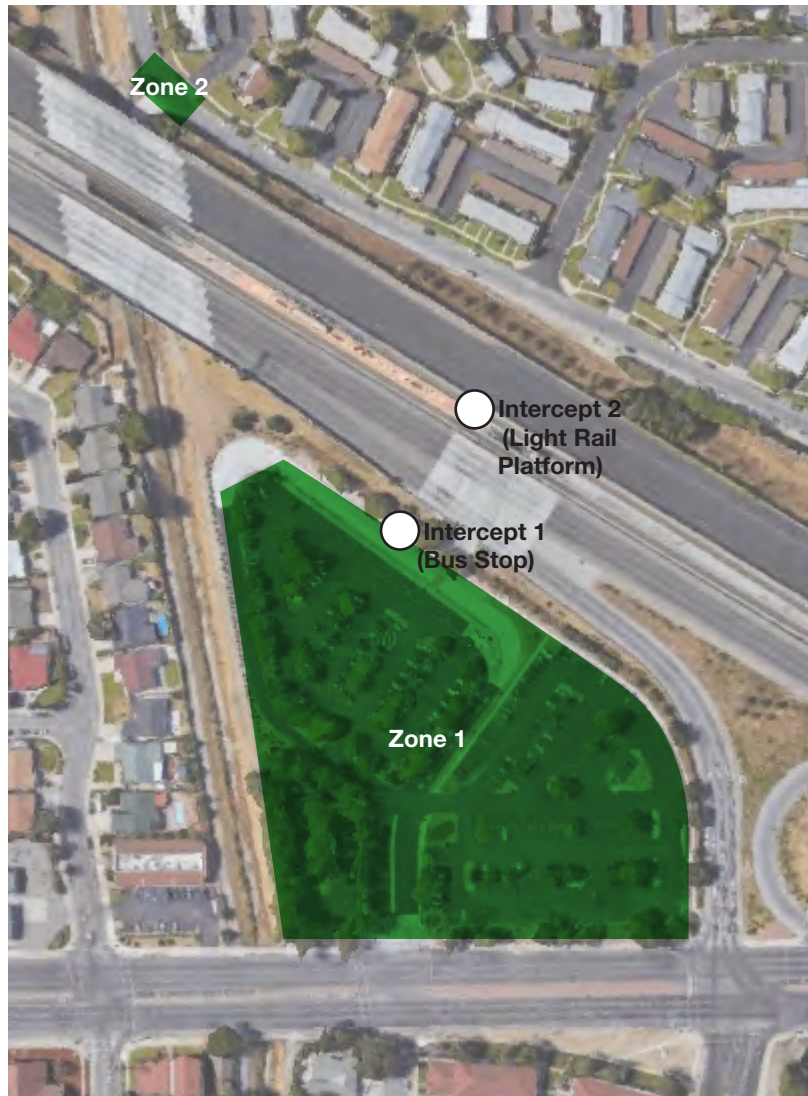
# Figure 3.1: Data Collection Locations

The top modes of arrival and departure at each of the data collection zones within Blossom Hill Station are also shown in Figure 3.1. The mode splits are detailed further in Section 3.1. Access by car is most popular in Zone 1, while access by walking is most popular in Zone 2.

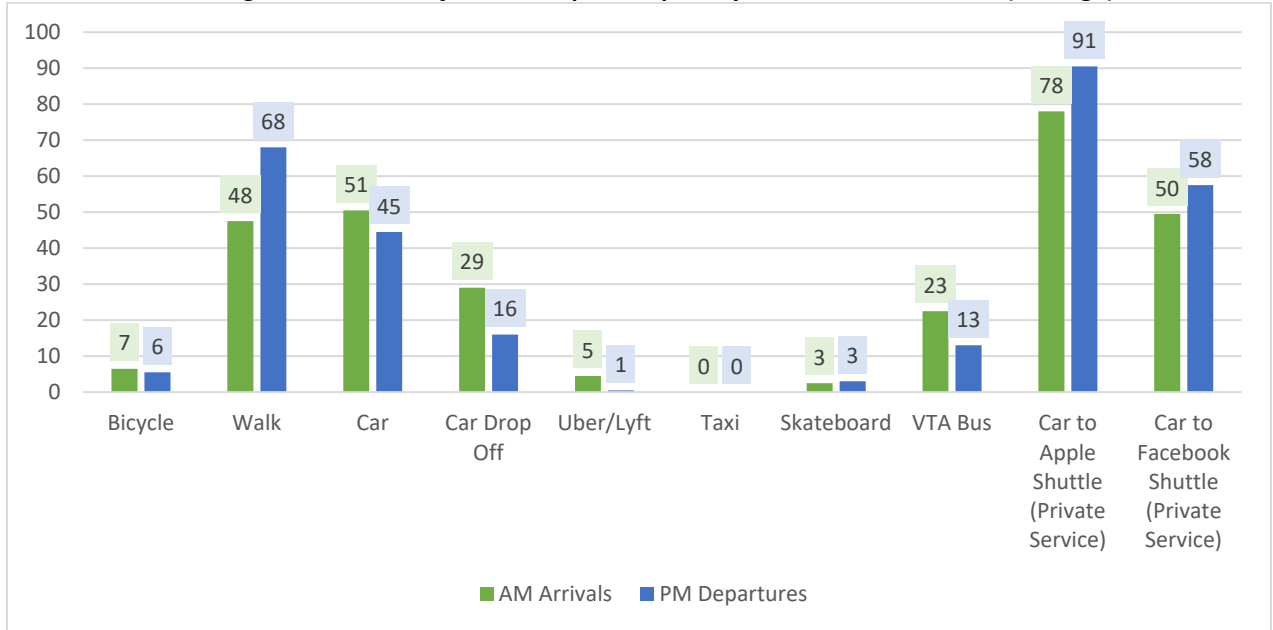
**Figure 3.2: Modes of Arrival/Departure per day at Blossom Hill Station (Average)**

Figure 3.2 shows the average number of each mode of arrival/departure observed at Blossom Hill Station over the two data collection days, and Figures 3.3 and 3.4 show the average number of arrivals and

On an average day, during the AM collection hours, the most common mode of arrival was by car. A total of 179 people, on average, arrived to Blossom Hill Station by car. Out of those 179 arrivals, only 51 then transferred to a form of VTA transit. The other 128 people arrived to the station by car to take a private shuttle, either to the Apple (78), or Facebook (50) campuses. Of those passengers taking private shuttle, car was the only initial mode of arrival recorded. The next two most common modes to access VTA transit services were walking (48) and car drop-off (29). Note that car drop-offs were distinct from Uber/Lyft drop-offs.

During the PM collection hours on an average day, the observed mode share was similar to the morning, with a total of 194 people, on average, departing Blossom Hill Station by car. Twenty-three percent of departures by car had taken VTA transit, while the other 77 percent had arrived back to the station by private shuttle, before departing by car. Out of the 77 percent that arrived back to the station by private shuttle, 91 passengers arrived from Apple while 58 arrived from Facebook, before departing the station by car. This was followed by walking (68) and car pick-up (16), as the most popular mode share options. No trips departed the station by taxi.

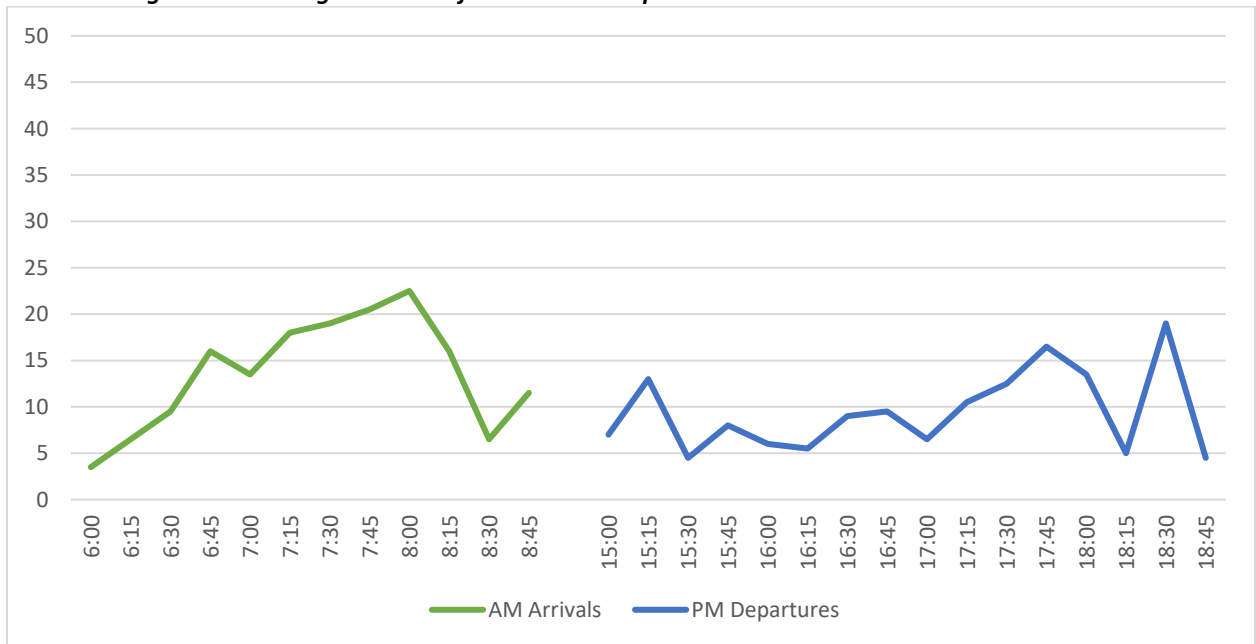
**Figure 3.3: Average Number of Arrivals and Departures at Blossom Hill Station – VTA Transit Users**

departures counted over time during both the AM collection hours and PM collection hours at Blossom Hill Station, organized by VTA transit users and private shuttle users, respectively.

Peaks in arrival of VTA transit users were observed at 8:00 AM and 7:45 AM. Arrival of private shuttle users peaked at 8:15 AM, followed by peaks at 7:15 AM and 7:45 AM.

Slight peaks in departure of VTA transit users were observed at 6:30 PM and 5:45 PM, while larger peaks in departure of private shuttle users were observed at 5:00 PM, 5:45 PM, and 6:15 PM.

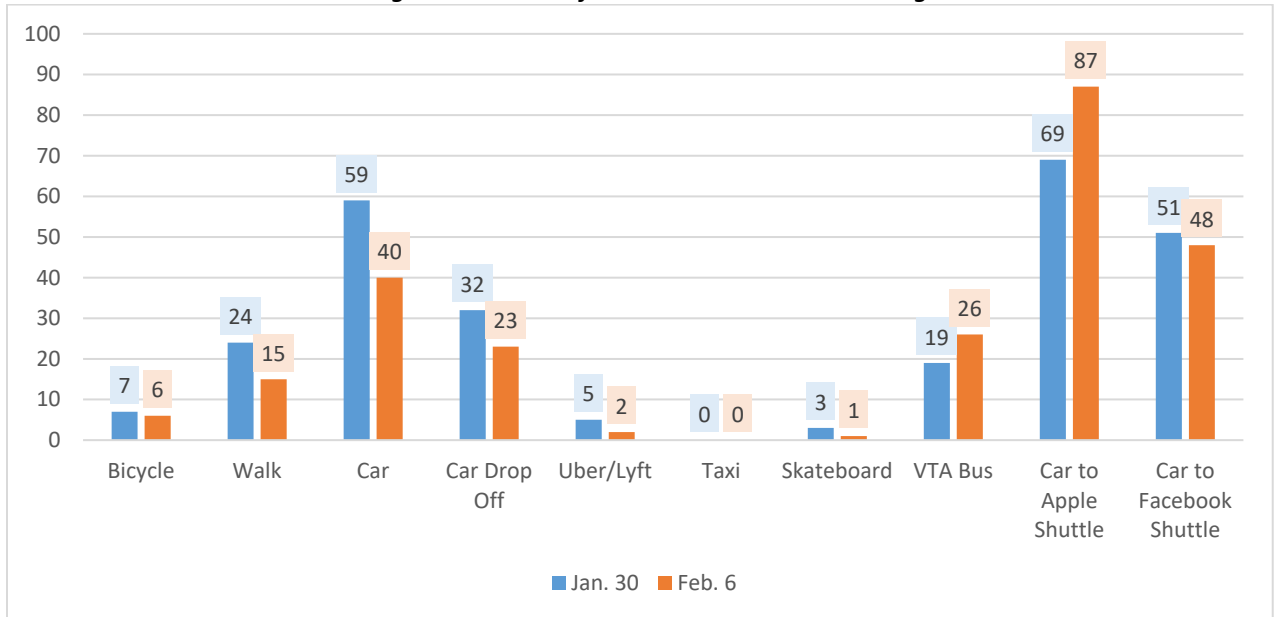
**Figure 3.5: Mode of Arrival at Zone 1: VTA Parking Lot**

On both January 30 and February 6, the majority of arrivals to the station through the VTA parking lot arrived by car. The majority of arrivals by car then took a private shuttle, rather than VTA transit. On January 30, this was followed by accessing the station by car drop-off or walking. On February 6, this was followed by accessing the station by VTA bus or car drop-off. There were fewer arrivals by bicycle, Uber/Lyft, and skateboard. No arrivals by taxi were observed on either day.

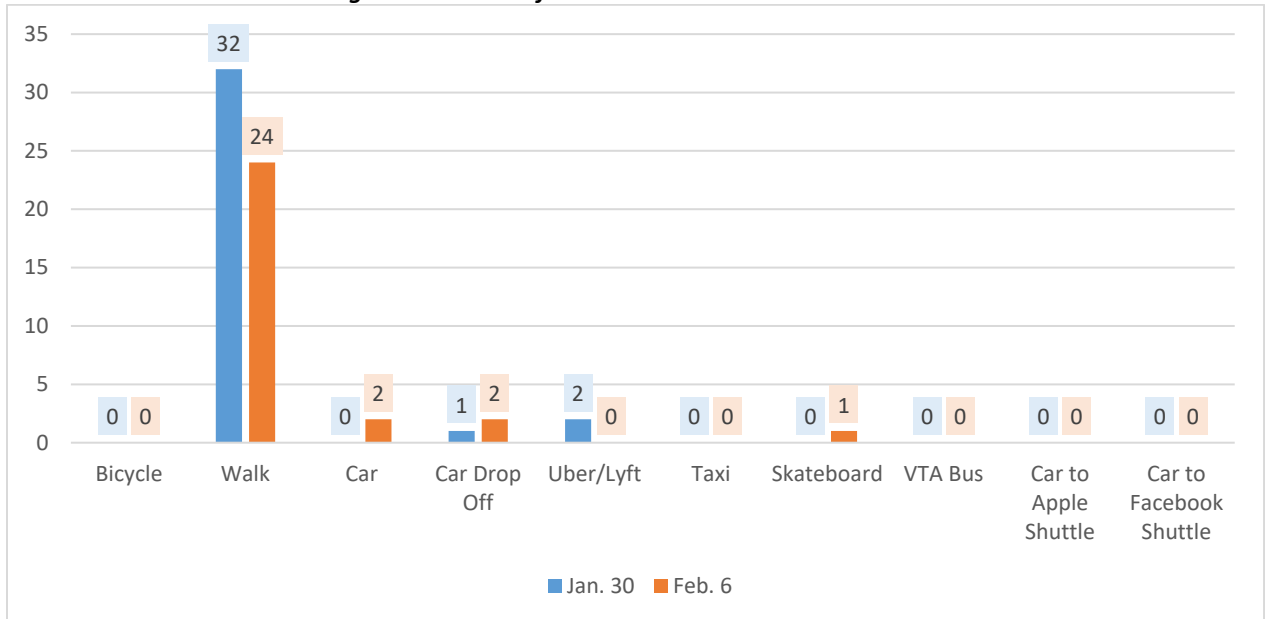
**Figure 3.6: Mode of Arrival at Zone 2: Entrance on Velasco Dr.**

On both January 30 and February 6, almost all people arriving to station through the entrance on Velasco Drive arrived by walking. On January 30, 3 people arrived by Uber/Lyft or car drop-off. On February 6, 4 people arrived by personal car or car drop-off, meaning two people parked their vehicle on Velasco Drive before entering the station. One person arrived by skateboard. There were no other modes of arrival noted during the AM arrival collection hours at the entrance on Velasco Drive.

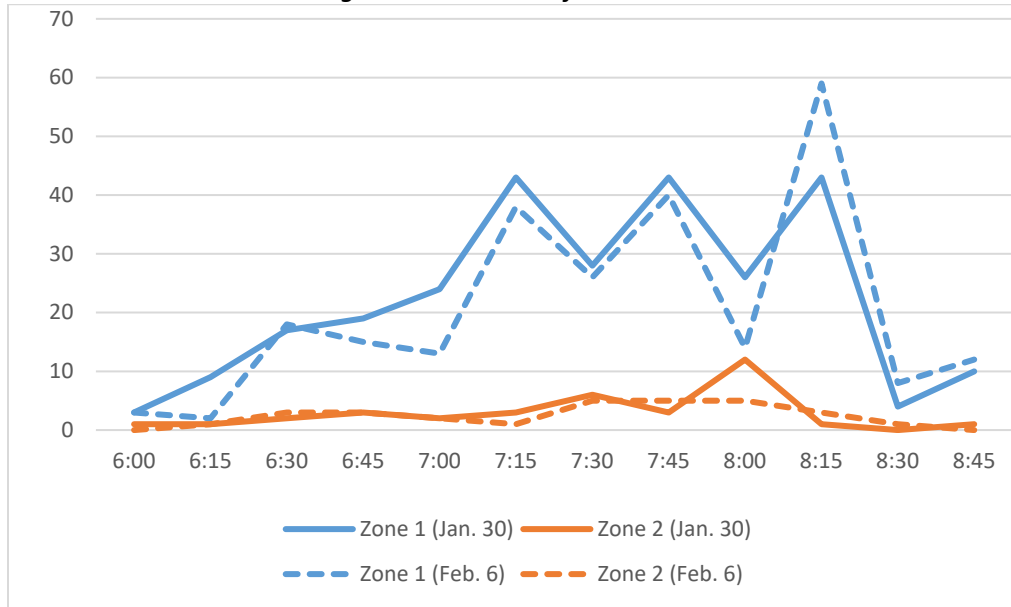
**Figure 3.7: AM Time of Arrival at Each Zone**

The number of total arrivals to the station was much higher via the VTA parking lot than via Velasco Drive on both data collection days. The number of arrivals through the VTA parking lot are relatively low until 7:00 AM, when arrivals begin to increase more sharply on both days. Arrivals peaked at 8:15 AM on both days, followed by a rapid decline for the rest of the morning. Secondary peaks in arrival occurred at 7:45 AM and 7:15 AM. These peaks correlate with arrival of northbound weekday Blue Line service at 8:18 AM, 7:48 AM, and 7:18 AM.<sup>1</sup>

The number of arrivals through the entrance on Velasco Drive also remain relatively low until 7:00 AM, before seeing an increase at 7:30 AM, and peaking at 8:00 AM on both days. Peaks in arrival at Velasco Drive seem to occur during the intervals in which arrivals through the VTA parking lot seem to peak, and vice versa. This may be due to arrival in westbound Route 27 bus service at 8:13 AM and 7:43 AM, picking up passengers at these times, when there is a perceived dip in arrivals in Zone 2.

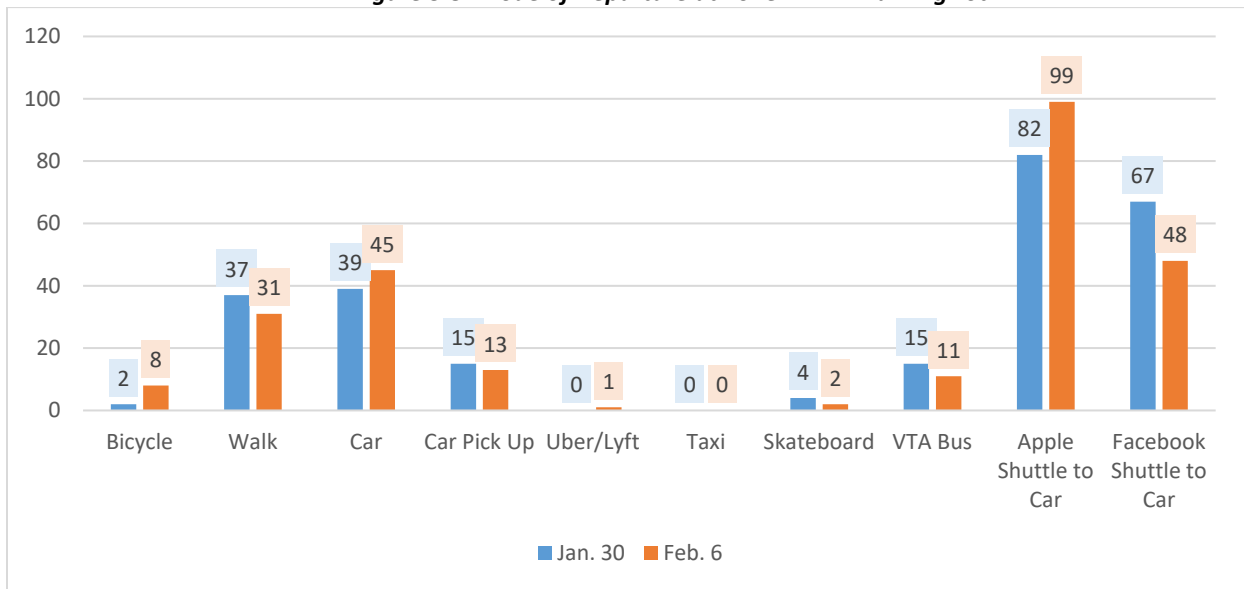
**Figure 3.8: Mode of Departure at Zone 1: VTA Parking Lot**

On both January 30 and February 6, the majority of departures the station through the VTA parking lot departed by car. The majority of departures by car had arrived back to the station by a private shuttle, rather than VTA transit. On January 30, this was followed by departing the station by walking, and then car pick-up or VTA bus. On February 6, this was followed by departing the station by walking or car pick-up. Similar to the number of arrivals observed, there were fewer departures by bicycle, Uber/Lyft, and skateboard. No departures by taxi were observed on either day.

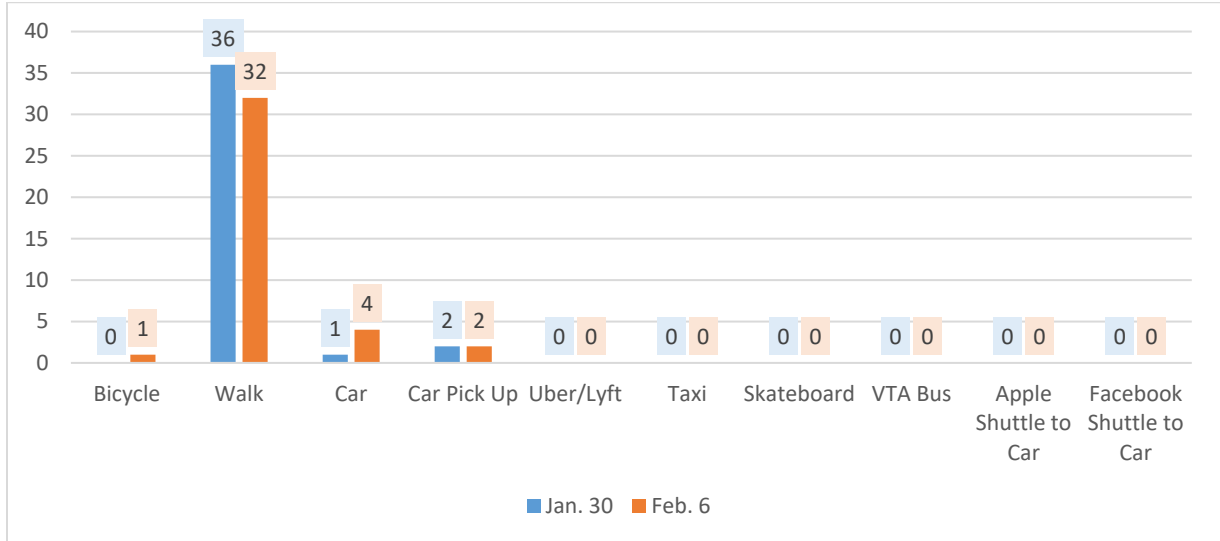
**Figure 3.9: Mode of Departure at Zone 2: Entrance on Velasco Dr.**

On both January 30 and February 6, almost all people departing station through the entrance on Velasco Drive departed by walking. On January 30, three people departed by Uber/Lyft or car pick-up. On February 6, six people departed by personal car or Uber/Lyft. One person departed by bicycle. There were no other modes of departure noted during the PM departure collection hours at the entrance on Velasco Drive.

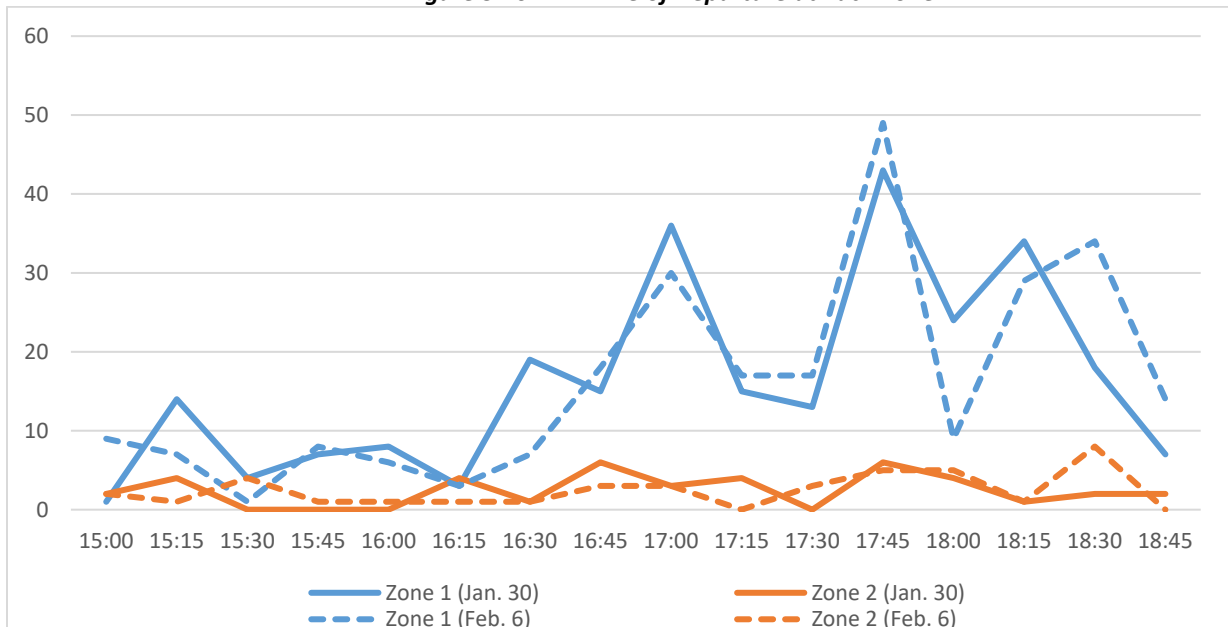
**Figure 3.10: PM Time of Departure at Each Zone**

Similar to the observation of arrivals, the number of departures from the station was much higher via the VTA parking lot than via Velasco Drive on both data collection days. The number of departures through the VTA parking lot are relatively low until about 4:30/4:45 PM. Peaks in departure then occurred at 5:45 PM, 5:00 PM, and 6:15/6:30 PM, relatively consistent with the arrival of southbound Blue Line service.

The departure profiles through Velasco Drive show more of a contrast between both data collection days. Peaks in departure on January 30 were observed at 5:45 PM and 4:45 PM, with smaller peaks occurring throughout the afternoon. The peak number of departures on February 6 occurred at 6:30 PM, followed by smaller peaks at 5:45 PM/6:00 PM and 3:30 PM.

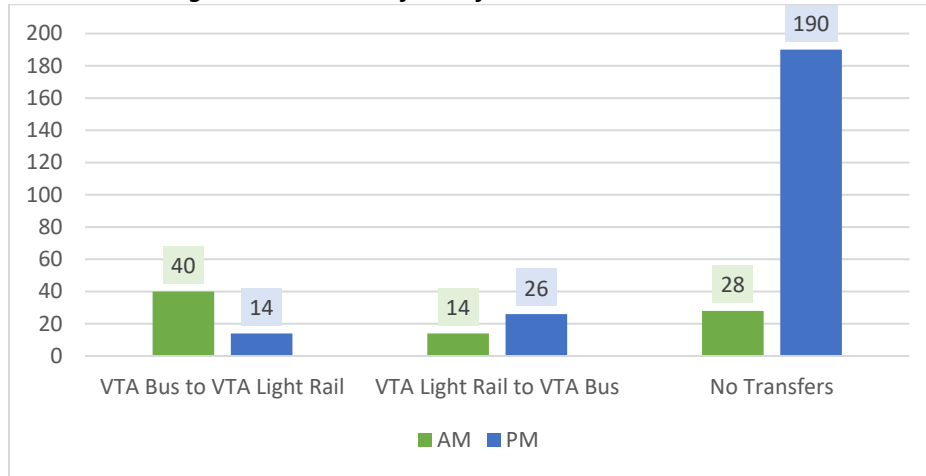
**Figure 3.11: Modes of Transfer Observed at Blossom Hill Station**

Figure 3.11 summarizes the total number of each mode of transfer recorded by intercept survey at Blossom Hill Station over both data collection days.

During the AM data collection period, the most popular mode of transfer was from VTA bus to VTA light rail (40).

During the PM data collection period, the majority of people arriving to Blossom Hill Station indicated that they were not transferring to another mode of transit (190). Of those transferring to another mode of transit, most respondents indicated a transfer from VTA light rail to VTA bus (26).

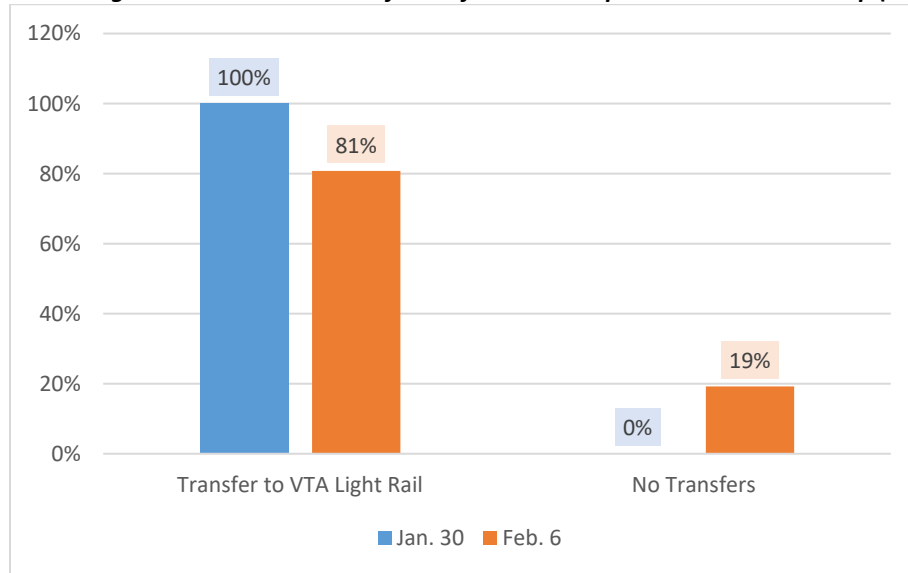
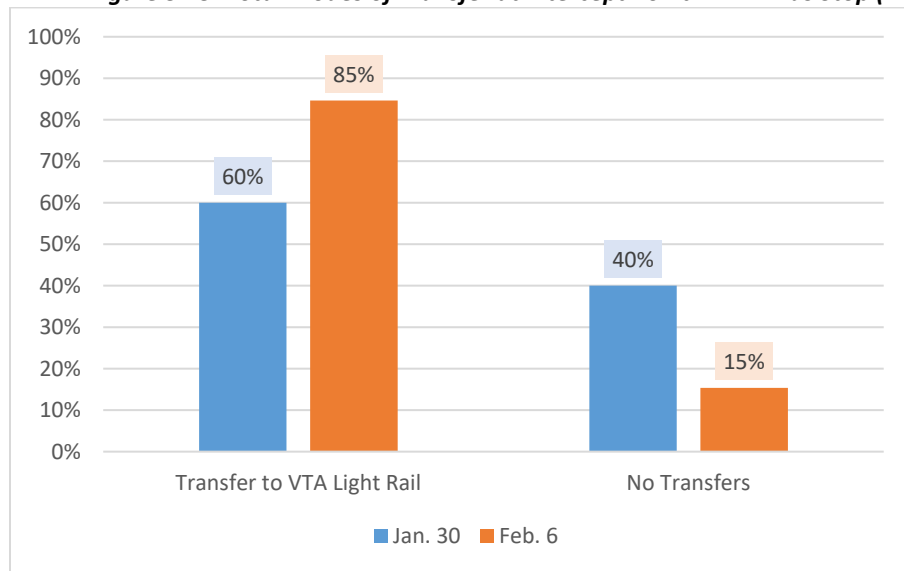
**Figure 3.12: Total Modes of Transfer at Intercept Point 1: VTA Bus Stop (AM)**

**Figure 3.13: Total Modes of Transfer at Intercept Point 1: VTA Bus Stop (PM)**

At Intercept Point 1: VTA Bus Stop, the majority of people surveyed were transferring to VTA light rail during the morning on both January 30<sup>th</sup> and February 6<sup>th</sup> (100 percent and 81 percent, respectively). During the afternoon, the majority of people were also transferring to light rail on both days, albeit at a smaller percentage (60 percent and 85 percent, respectively).

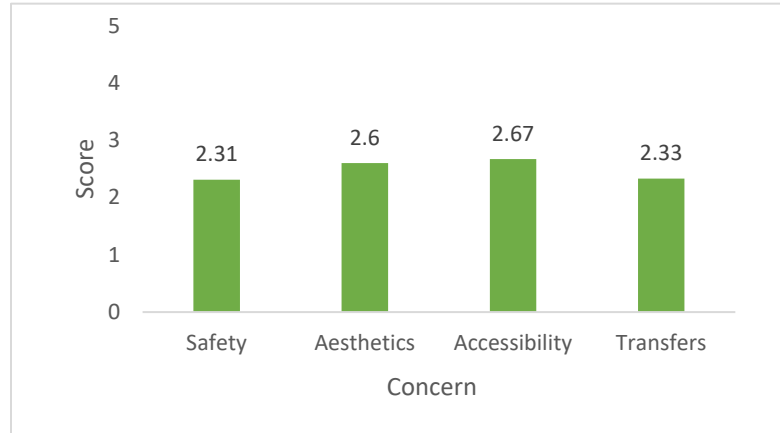
**Figure 4.1: Overall Scores by Category**

Auditors were also asked to rank their perceptions of several station area conditions categorized into the four categories of safety, aesthetics, accessibility, and transfers. Scores were given on a scale from one to five (five being the best possible score), or from strongly disagree to strongly agree. Amongst the categories, safety received the lowest overall average score. This score was closely followed by the transfers score (Figure 4.1).

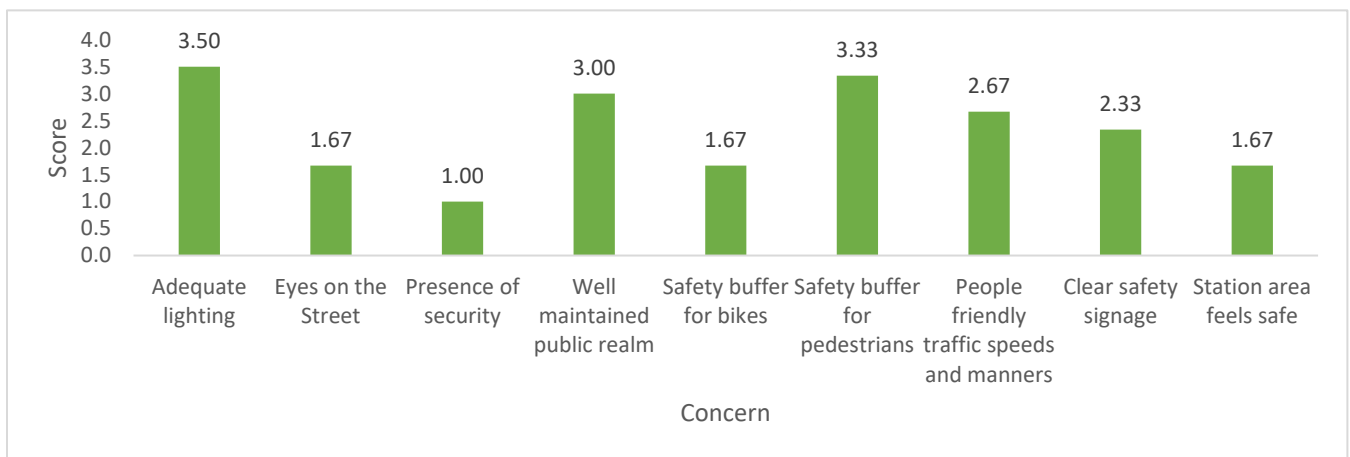
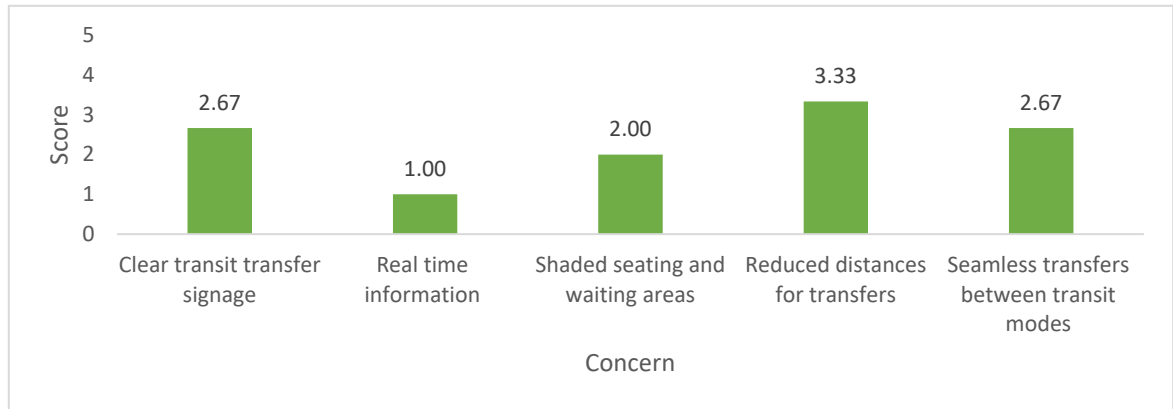
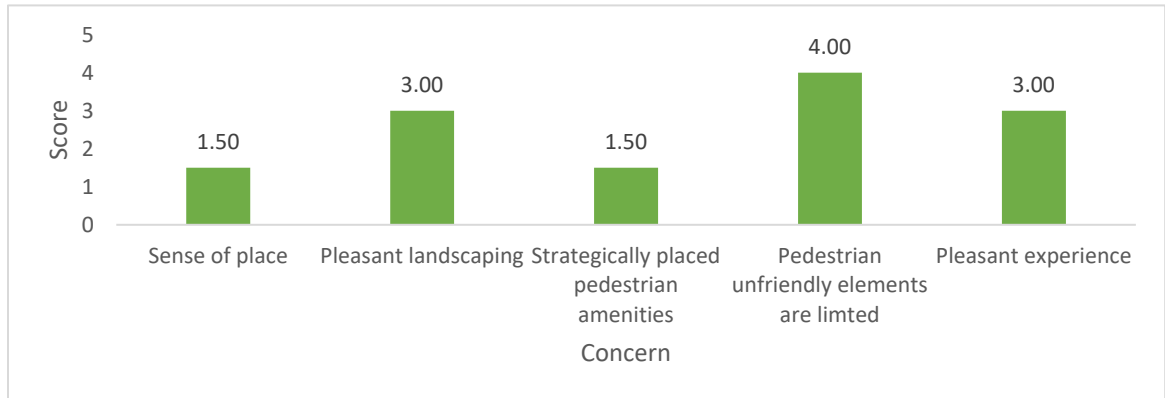
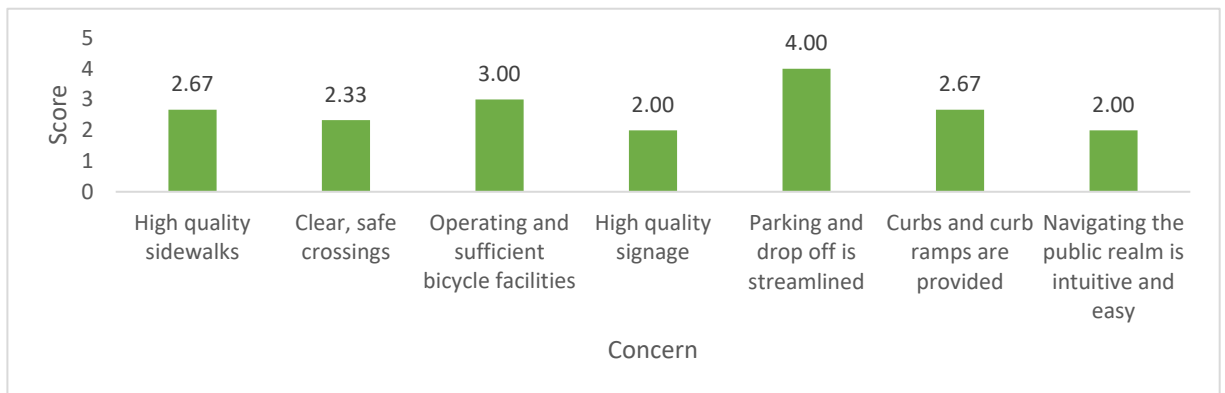
Within the safety category, auditors shared specific concern for the presence of security, eyes on the street, and the overall feeling of safety within the station area (Figure 4.2). Within the “transfers” category, auditors shared their concern for the availability of real time information (Figure 4.3). The aesthetics category received the second highest average score, however, auditors still raised concern for the placement of pedestrian amenities within the station area (Figure 4.4). The access category received the highest score across all categories, with the greatest support given to the streamlining of parking and drop-offs (Figure 4.5).
