2016 TRANSPORTATION SYSTEMS MONITORING REPORT (DRAFT)

September 2016

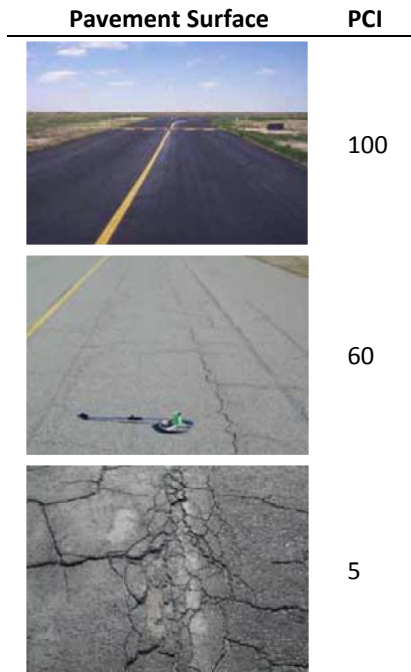
Figure 4
Example
Pavement
Surface &
PCI

PCI is based on the number and severity of pavement distresses observed during a visual inspection of a roadway. Visual examples of the PCI index scale are shown below.

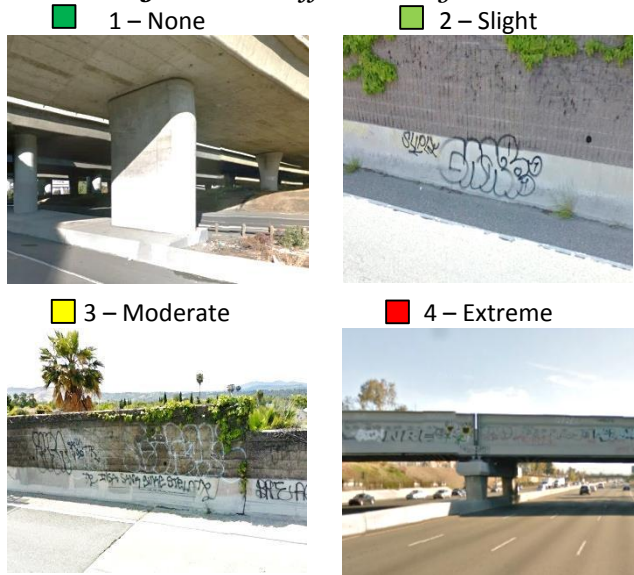
Figure 28. Graffiti Grading Scale.

Condition (Number)	Description
None (1)	No graffiti currently present.
Slight (2)	Some graffiti is present and likely small in size and may not be clearly visible. Not likely to be distracting to most drivers. Entire location has less than 36 square feet (6'x6') of graffiti.
Moderate (3)	Graffiti is present and likely medium in size and clearly visible. Distracting to most drivers and may hold drivers attention for a second. May constitute many clusters of small instances of graffiti or one to two medium sized instances. Entire location has less than 240 square feet (6'x40') of graffiti.
Extreme (4)	Either large solitary instance or large areas of smaller instances of graffiti, and are visible and obtrusive. Solitary instances are very distracting to drivers and may hold drivers attention for more than a second. May illicit concerns of neighborhood safety. Entire location has more than 240 square feet (6'x40') of graffiti.

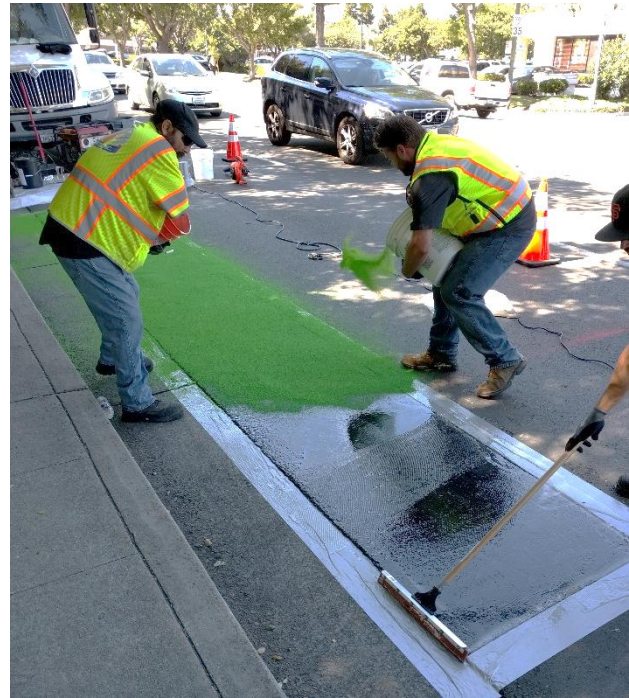
As the Santa Clara County continues to improve and expand its bicycle networks, one improvement that is being implemented are “green bike lanes.” Green bike lanes refers to the application of a green pigment, such as green paint, to help distinguish bicycle facilities from general purpose vehicle facilities.

Green bike lanes are typically installed at intersections where there are heavy vehicle and bicycle traffic volumes to increase visibility and provide a buffer between vehicle lanes and a bicycle lane.
